PCN# 20121203001

Correct RGMII transmit packet corruption,
USB in-rush current,
HDMI SDA/SCL pins on

MityARM-335x Development Kits

PCN Number: 20121203001
PCN Date: December 3, 2012
Title: Correct Transmit Packet Loss, USB inrush, HDMI DDC lines
Contact: Bill Halpin
Phone: (315) 425-4045
Ship Date: 03/01/2013

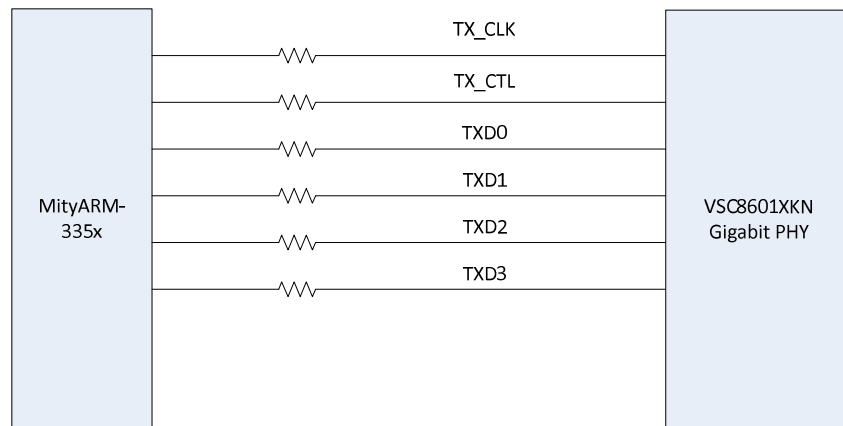
Figure 1 RGMII Transmit Data Path, Prior to Change

The signal termination for the RGMII data lines on the MityARM-335x development kit board has changed from series termination (see Figure 1) to R/C termination (see Figure 2) in order to improve the signal integrity margins and cross talk between the data lines and the RGMII transmit clock and data valid signals. In addition, the TX_CLK line was isolated from the data lines on the PCB layout.

Prior to the change, certain data patterns (for example, a packet containing all “0xF0” octet codes) transmitted from the MityARM-3359 SOM over the RGMII interface to the gigabit Ethernet PHY on the development kit host board could result in packet corruption and failed transmission. The packet corruption was due to signal cross talk to the transmit clock and control lines as well as a small amount of impedance mismatch on the data lines. The data corruption was only observable at low statistical rates when 3 or 4 data lines toggled simultaneously over large packet sizes. Patterns such as 0xF0, which transmitted as nibbles along the RGMII interface resulted in “bit-bang” style data patterns, were used to detect the error condition.
